SSC-337

SHIP FRACTURE MECHANISMS INVESTIGATION

SHIP STRUCTURE COMMITTEE

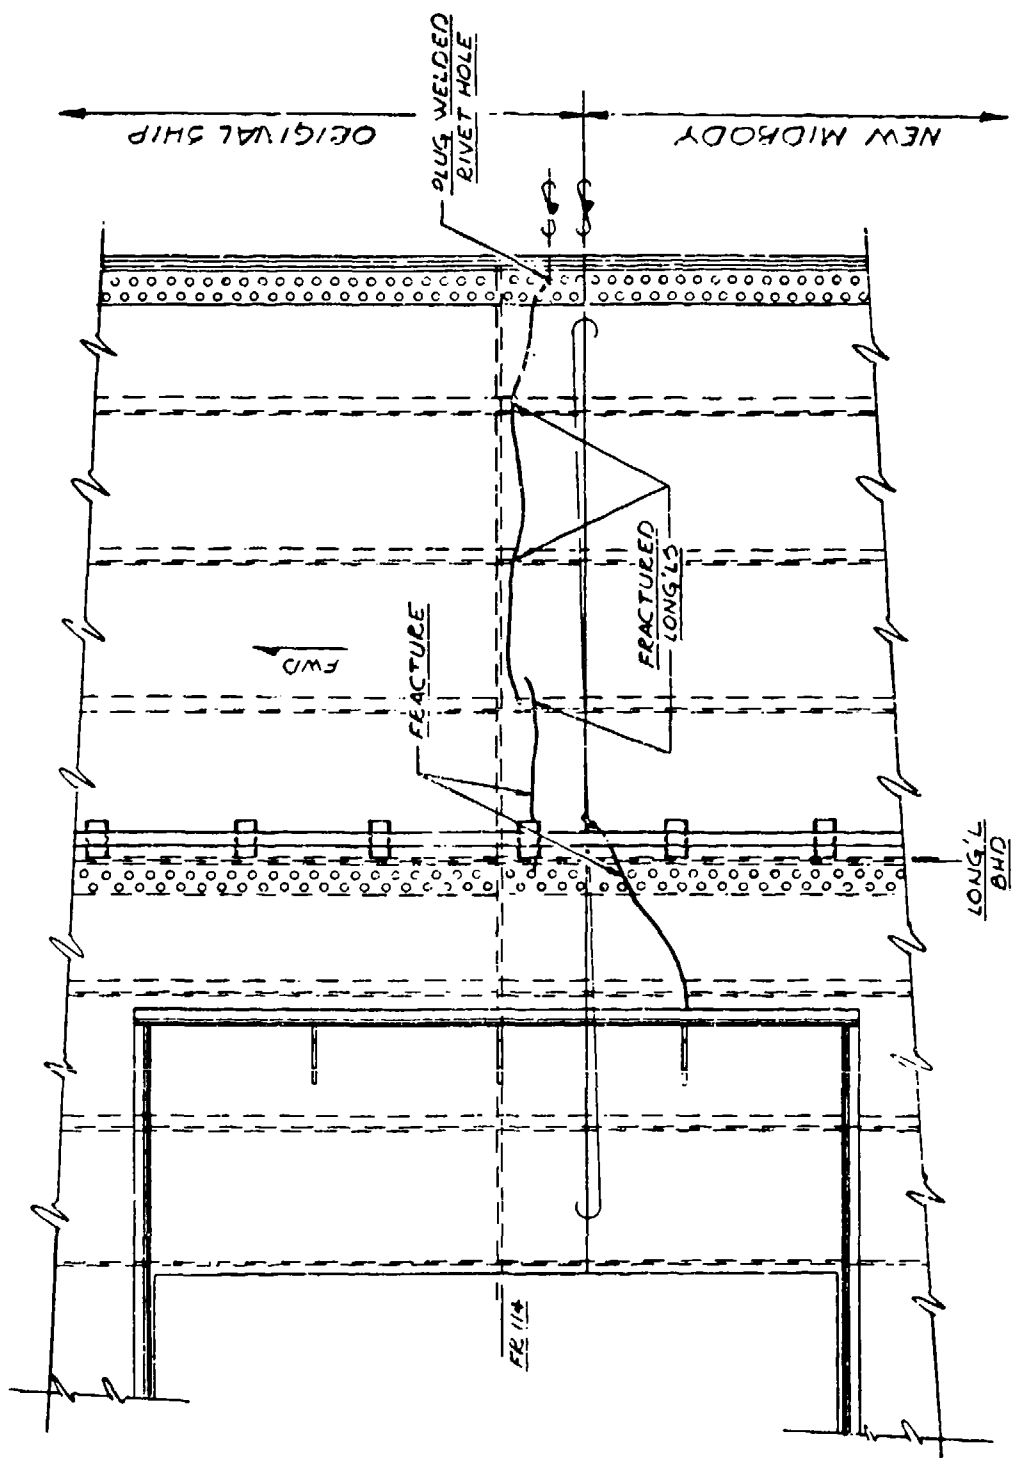
Figure 3-2 Fracture path on the spar deck of the Great Lakes bulk carrier

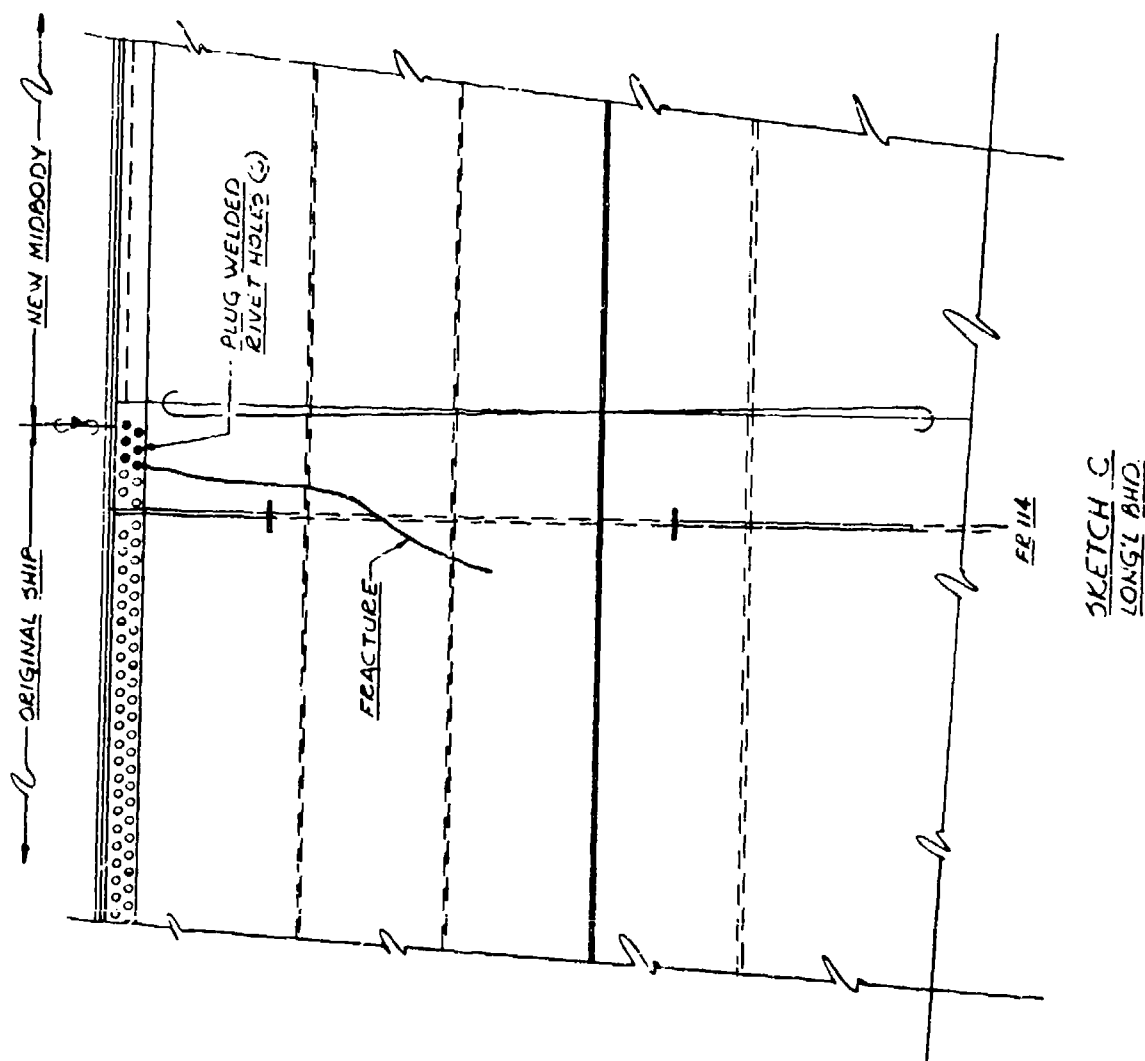
Figure 3-4 Fracture path in the Longitudinal Bulkhead of the Great Lakes Bulk Carrier

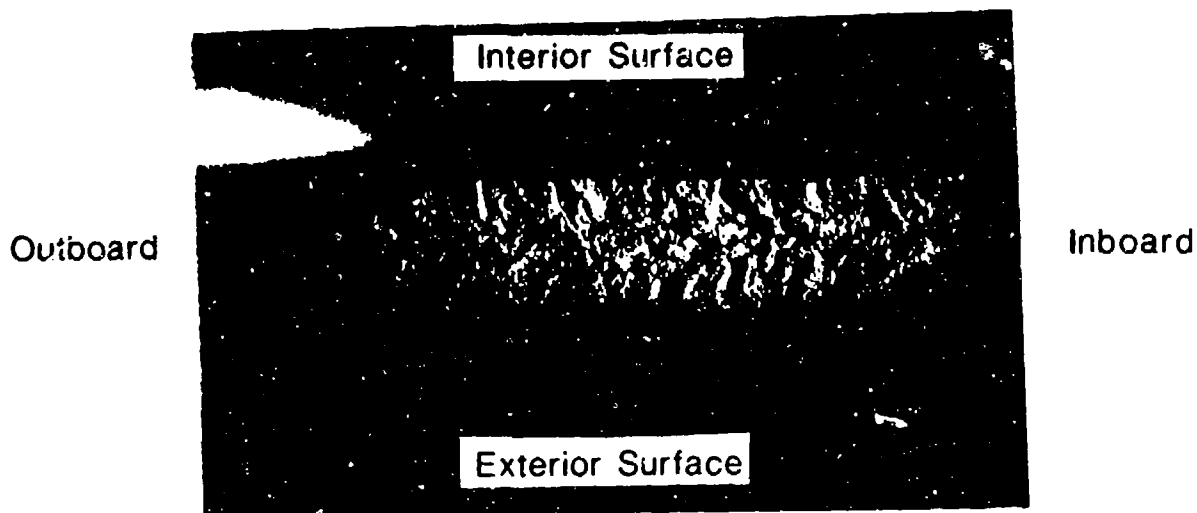
Figure 3-7a Example of chevron markers on the surface of Piece no. 1, indicating generally brittle fracture. Surface not completely flat, but markers are accentuated by oblique lighting.

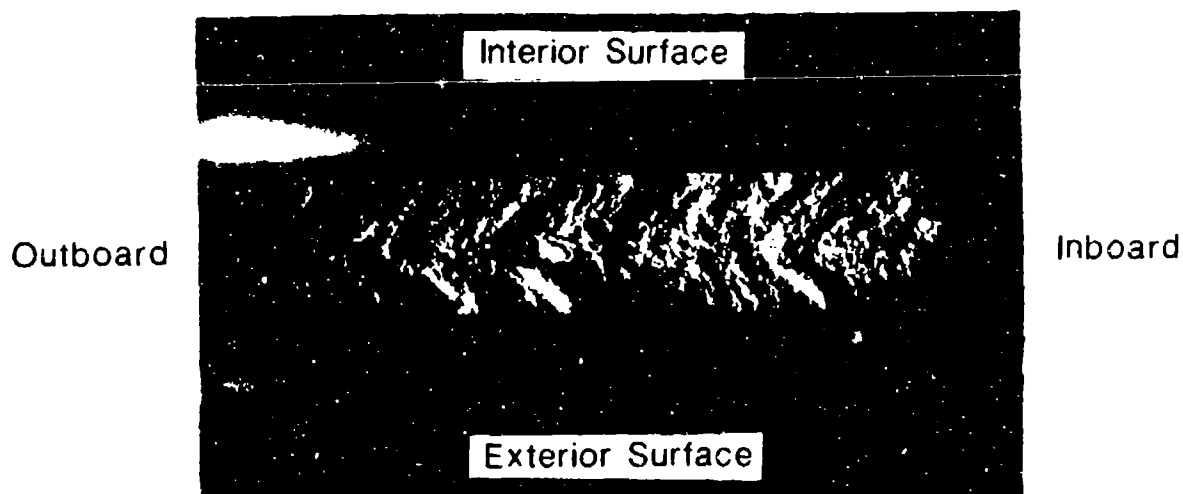
Figure 3-7b Fracture surface of Piece no. 1, oblique lighting. Somewhat more surface texture than seen in Figure 7a indicating increasing ductility in the fracture process, however no shear lip present.

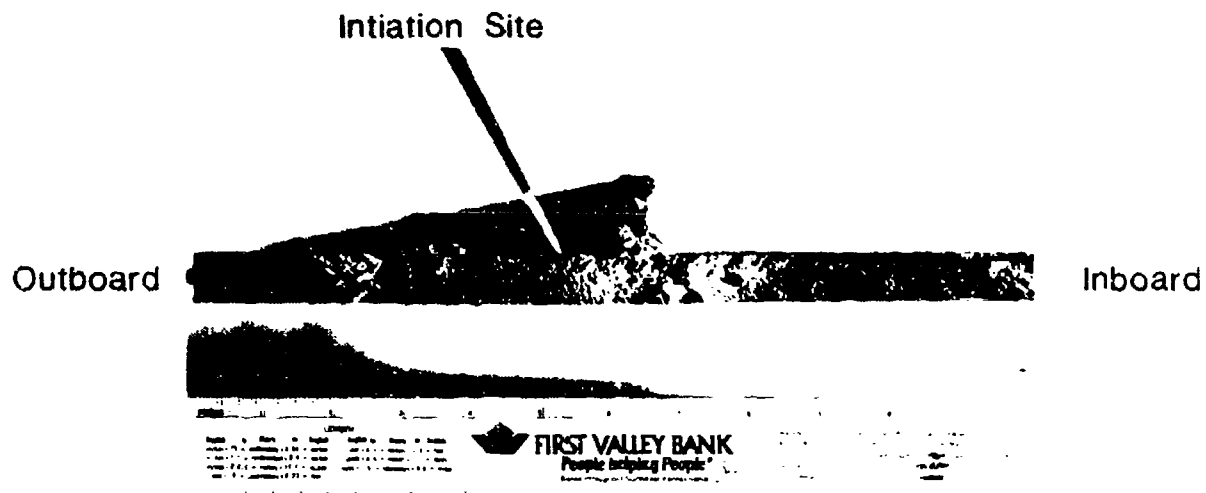
Figure 3-9 Piece no. 6. Fracture initiation site in deck at channel butt weld.

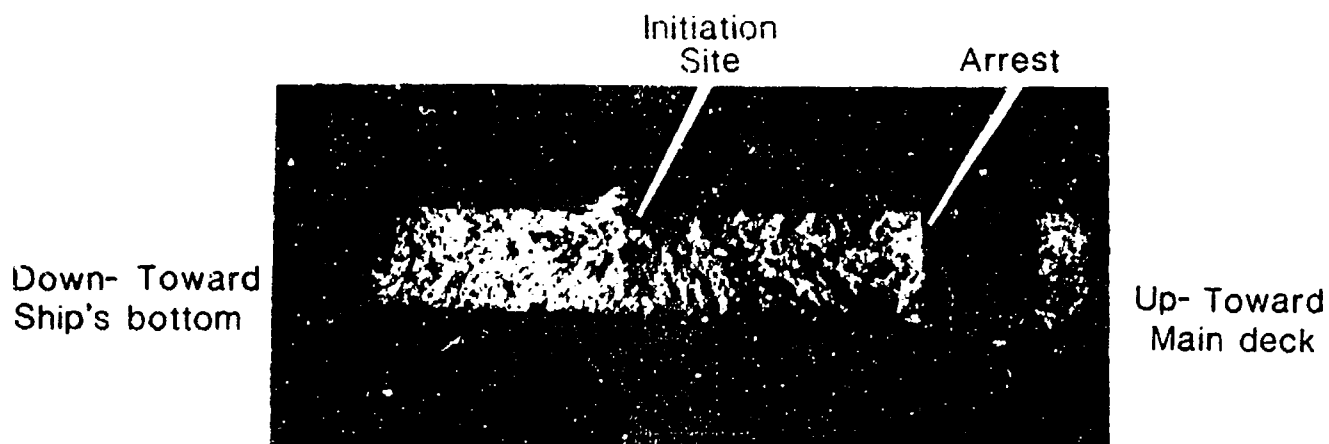
Figure 3-10 Piece no. 3 (top of longitudinal bulkhead) initiation site showing crack entering Piece no. 3 through weld of angle to Piece no. 3. Crack goes to rivet hole on right and down the bulkhead to left.

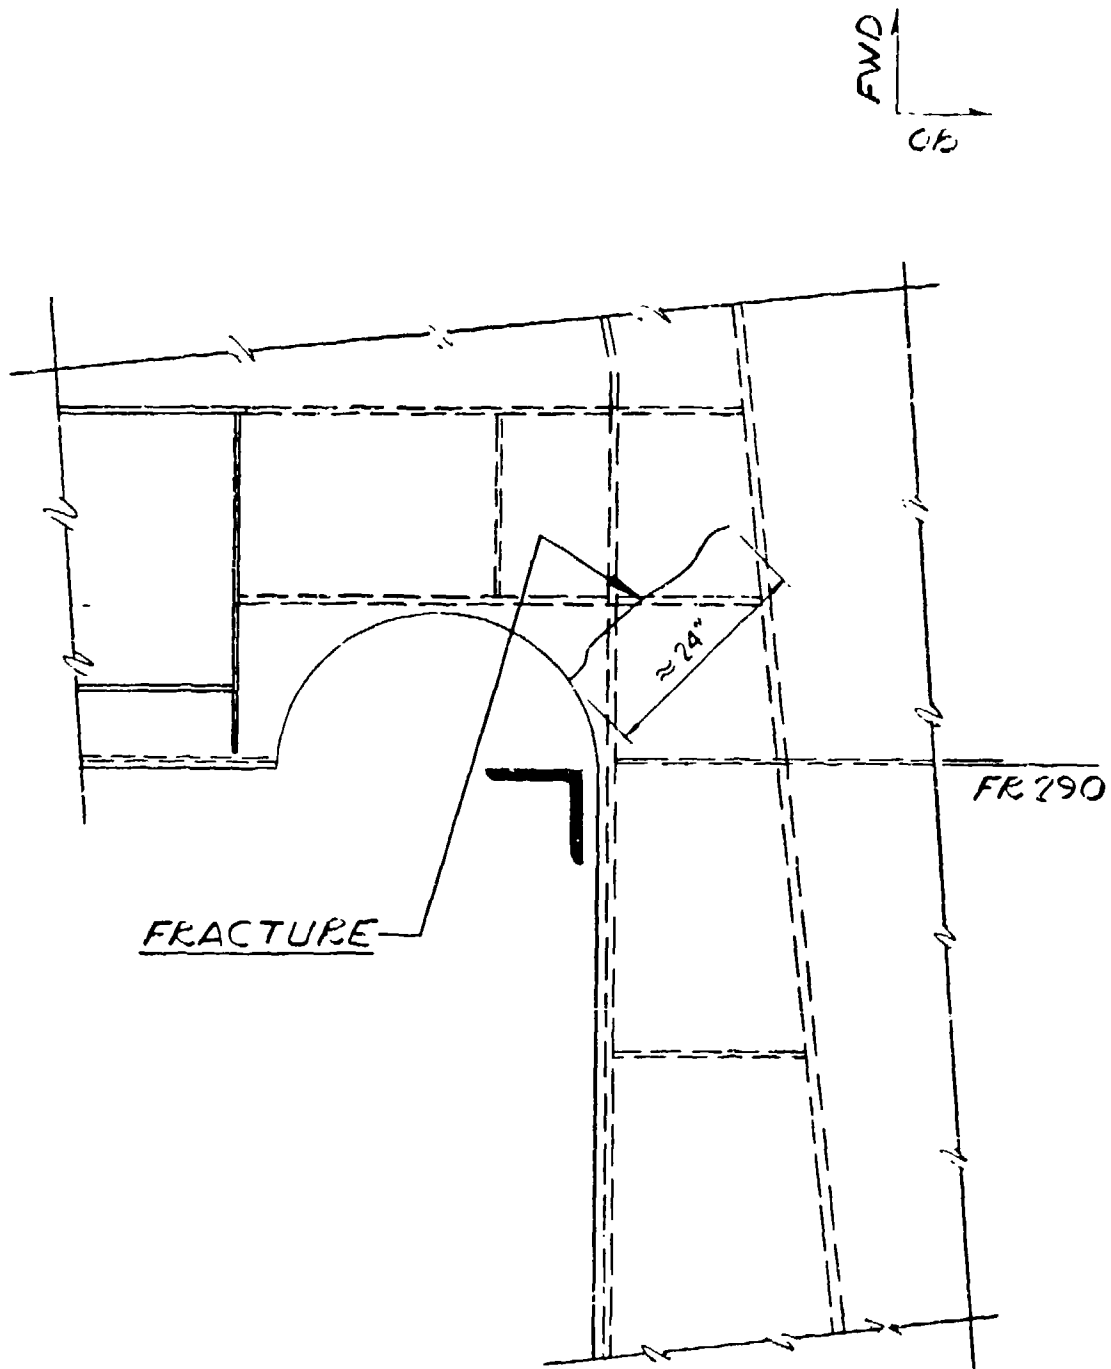
Figure 3-16 Fracture of the forward hatch cutout on the high speed containership during the second winter season

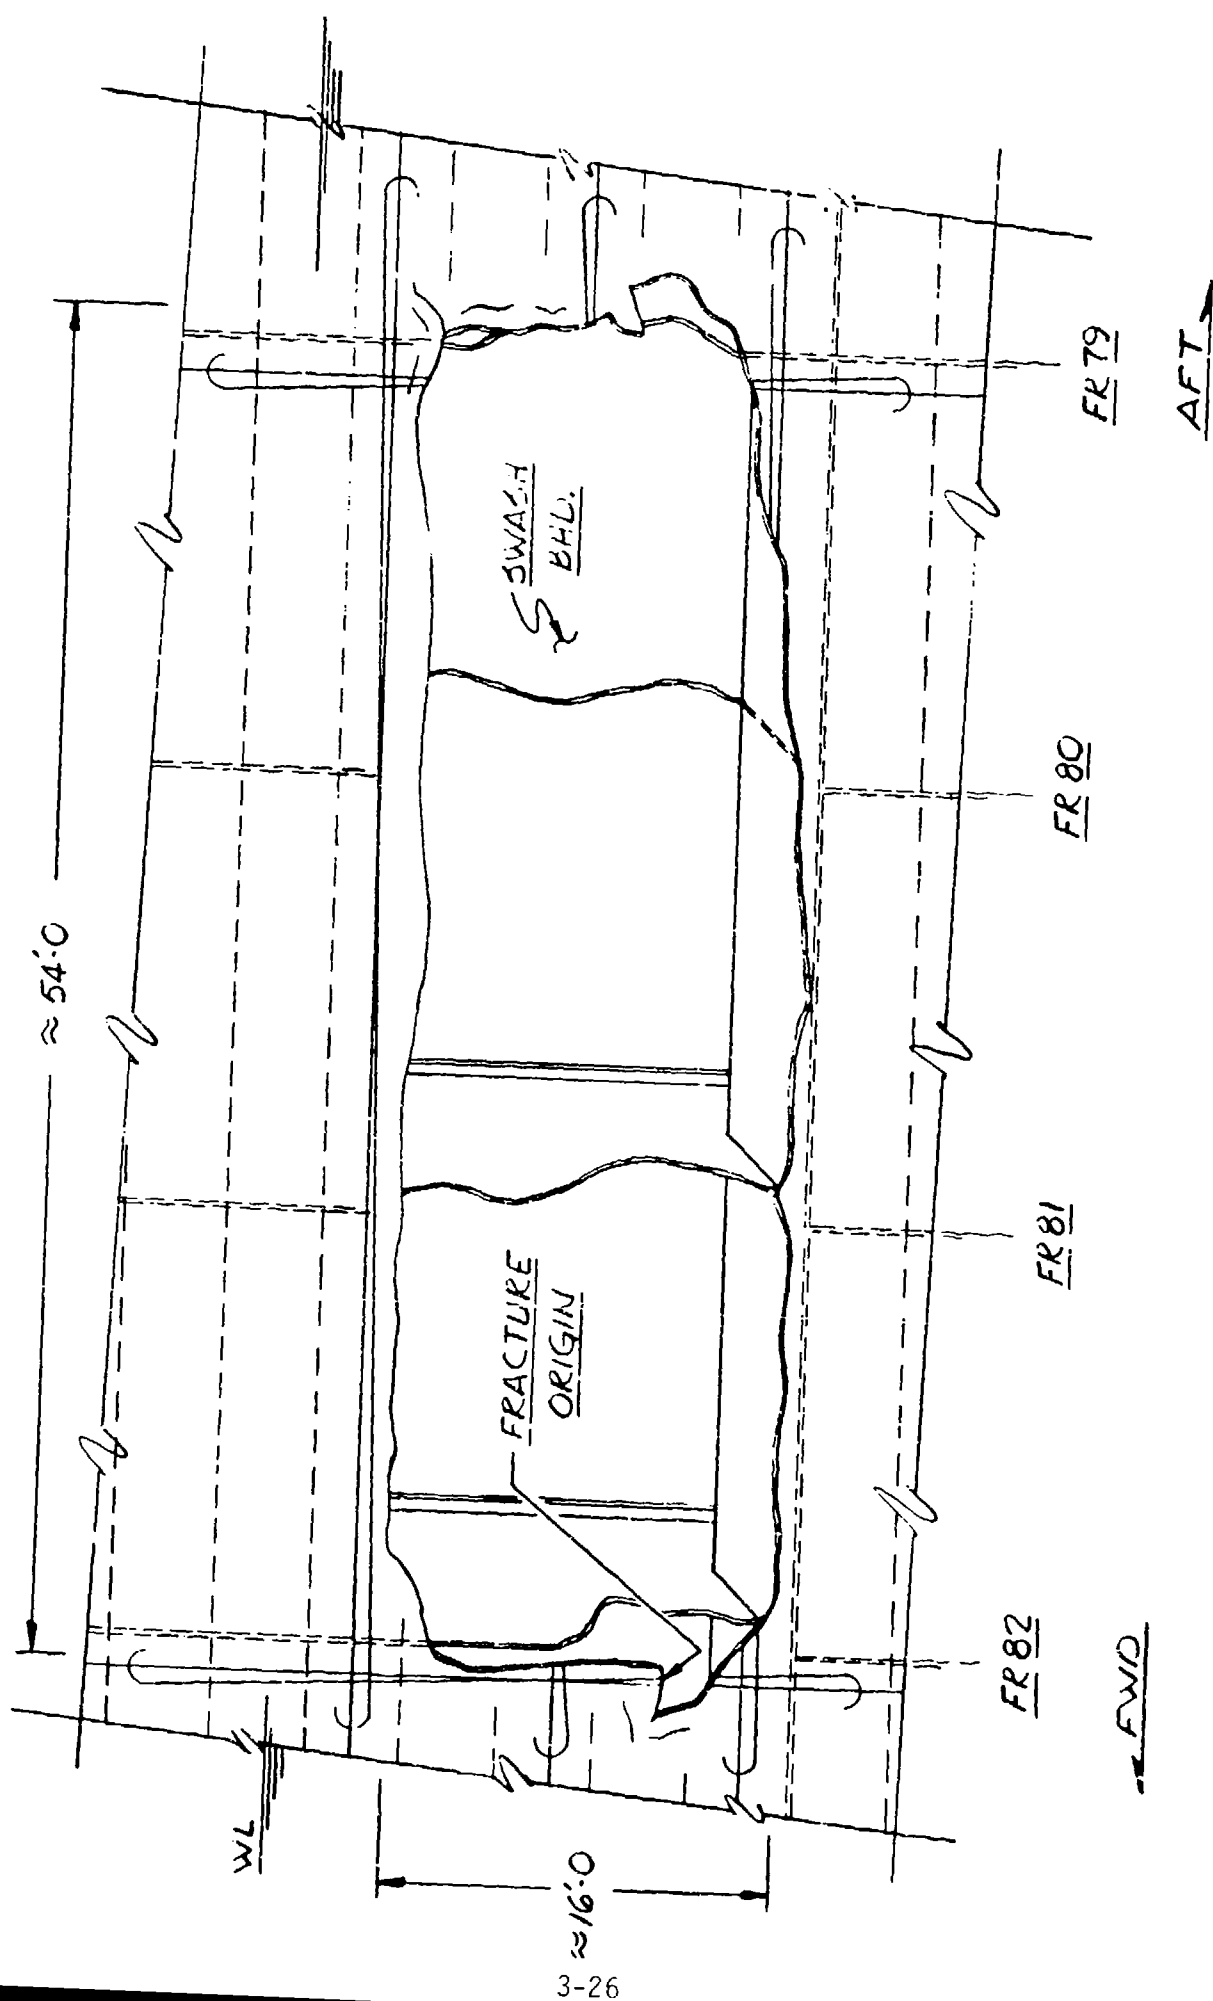
Figure 3-20 Configuration of fracture and loss of port side shell plating on the tanker

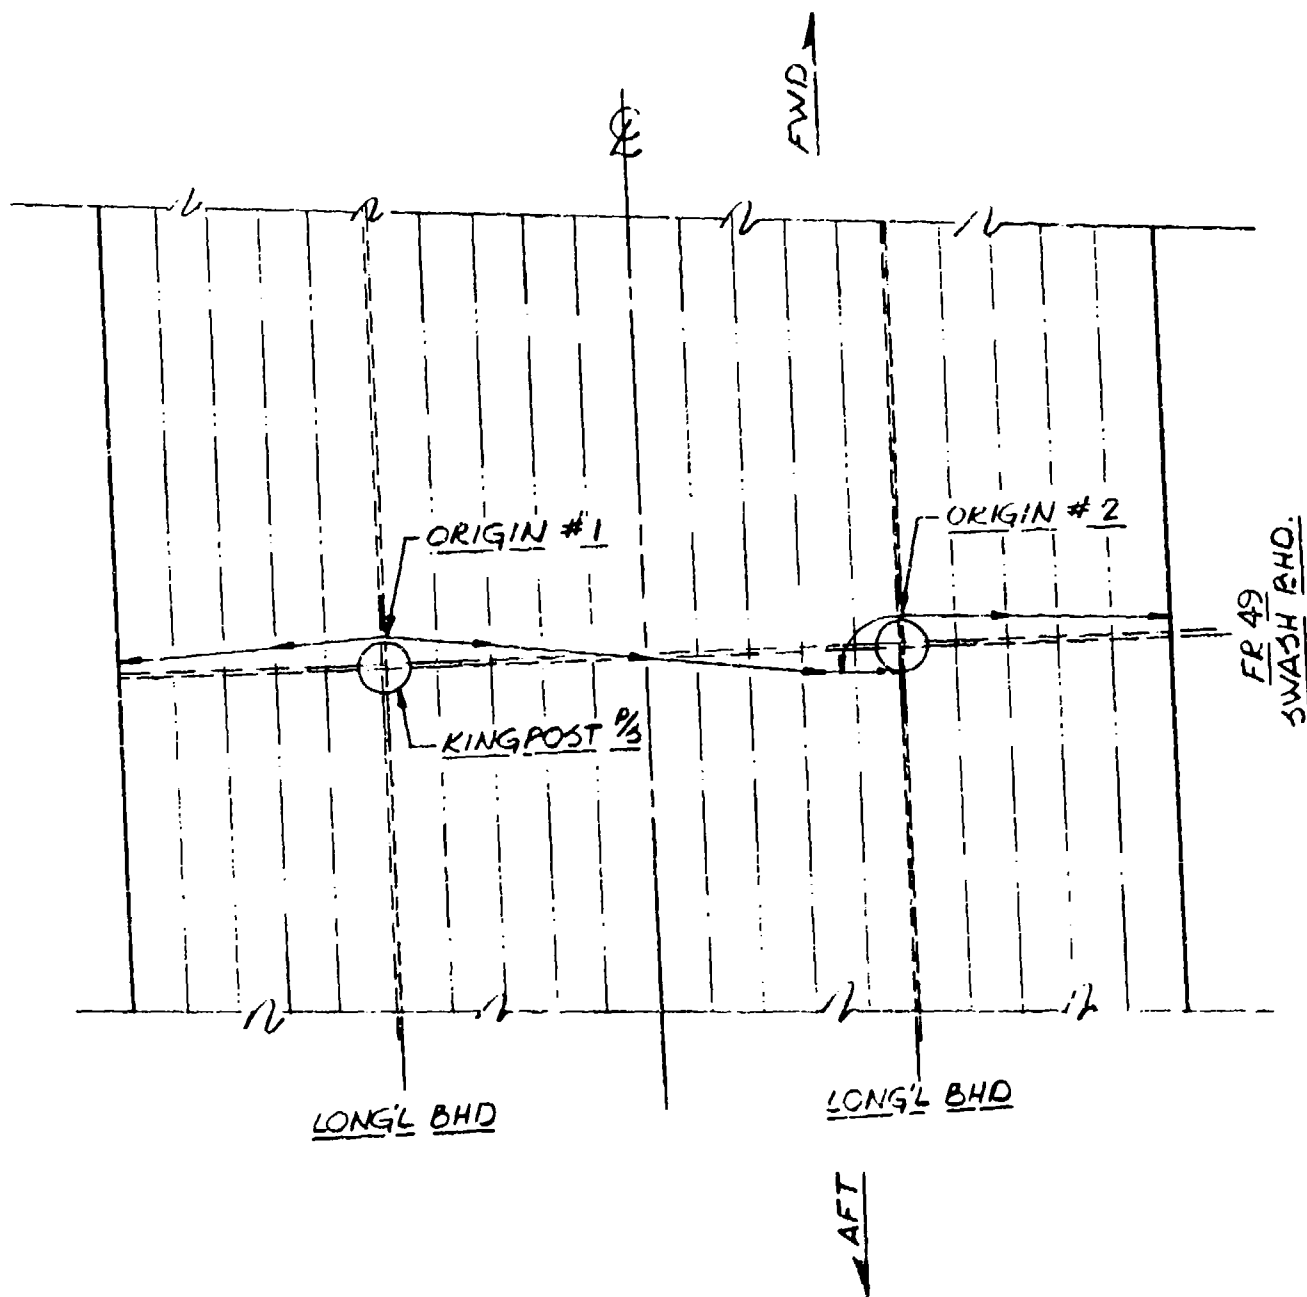
The fracture of the barge was generally in the vicinity of Frame 49, which is 42'-6" aft of the midpoint of the barge. The fracture extended completely across the main deck, down the side shell port and starboard, and across approximately 46 percent of the bottom plating. The configuration of the fracture path across the main deck is shown in Figure 3-21. The fracture originated at the base of a king post on the deck above the port longitudinal bulkhead. The king post was welded to a base plate doubler ring which was centered directly over the intersection of the transverse swash bulkhead at Frame 49

Figure 3-21 Fracture Path on the Main Deck of the Tank Barge

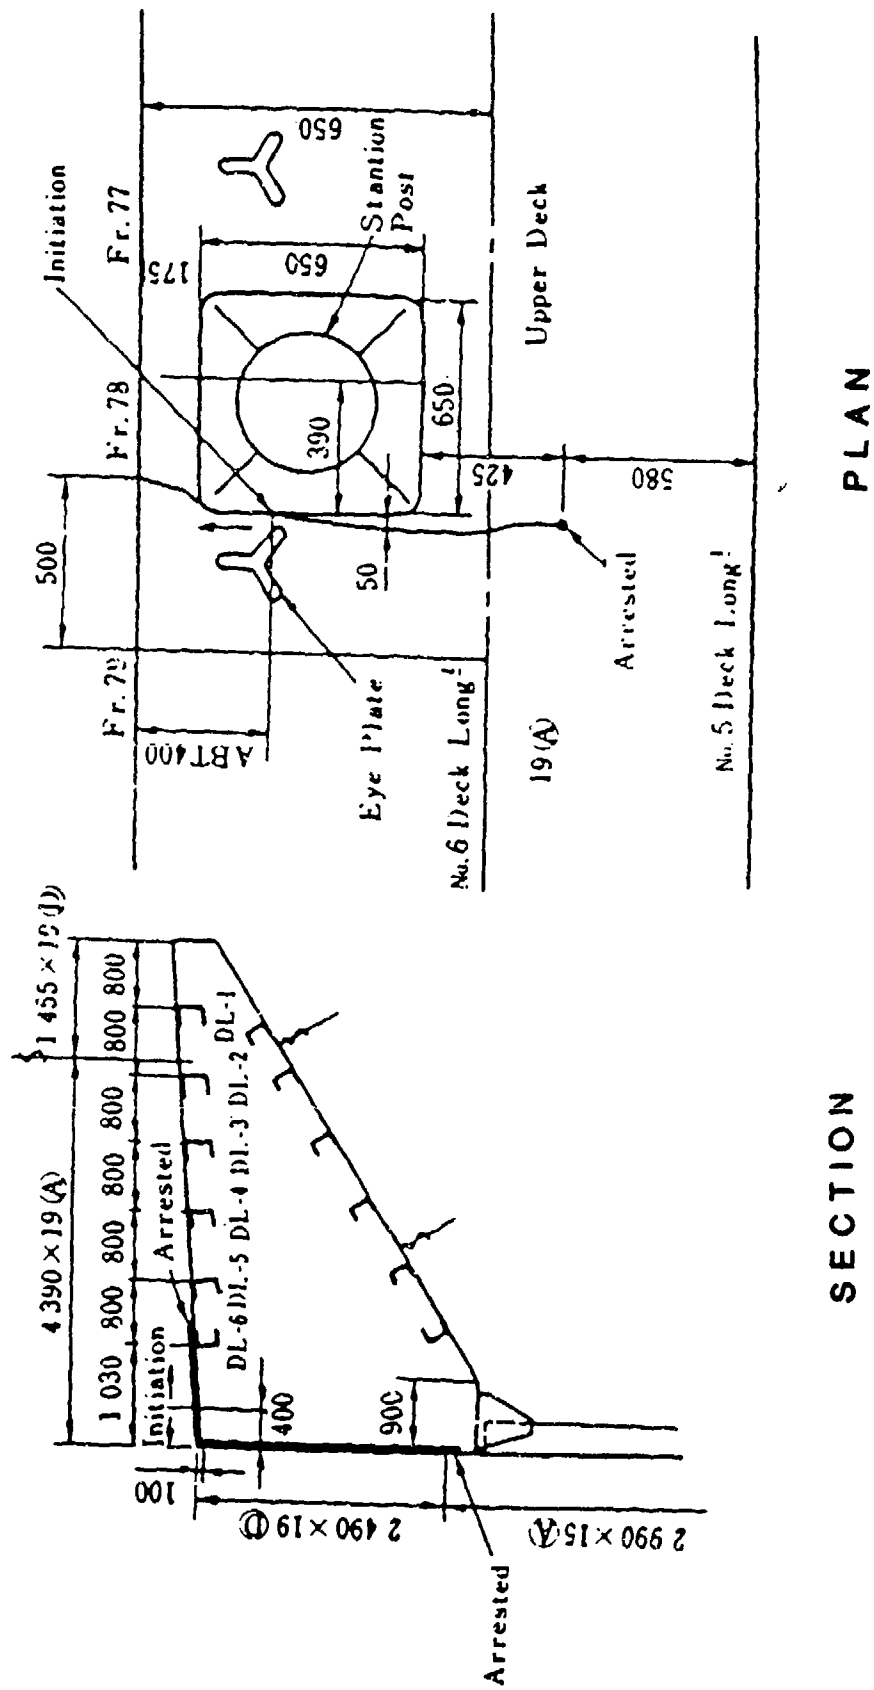
The brittle fracture propagated into the Grade D shear strake before it was arrested near the lower edge. The estimated stress intensity decreased as the lower edge of the shear strake was approached, due in part to the sloping bulkhead of the upper wing tank. Arrest was predicted where the stress intensity reached a value of K_{ca} . Actual arrest occurred at the edge of the shear strake.

Figure 3-24 Brittle Crack on Upper Deck of a Bulk Carrier

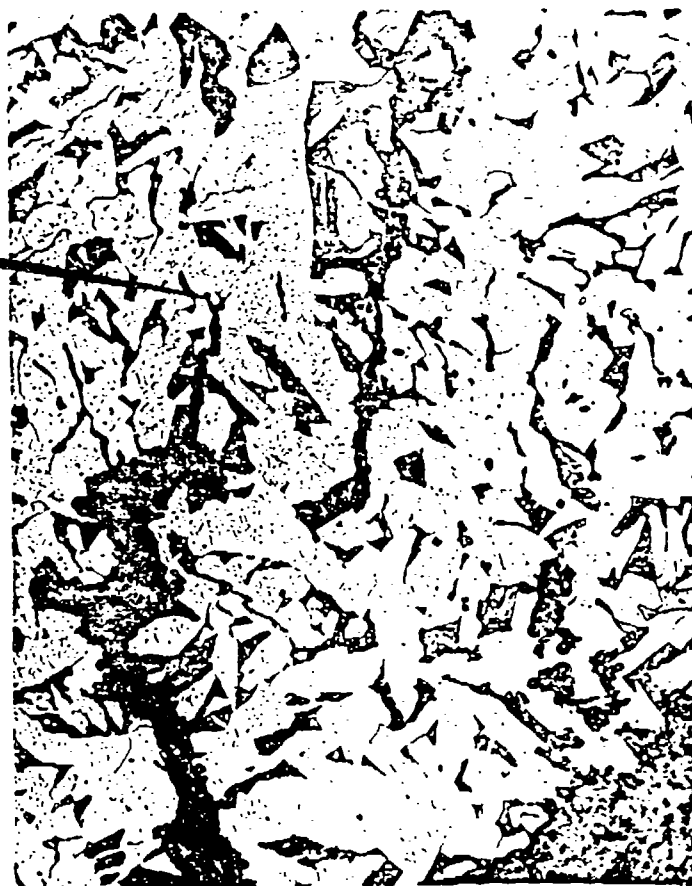
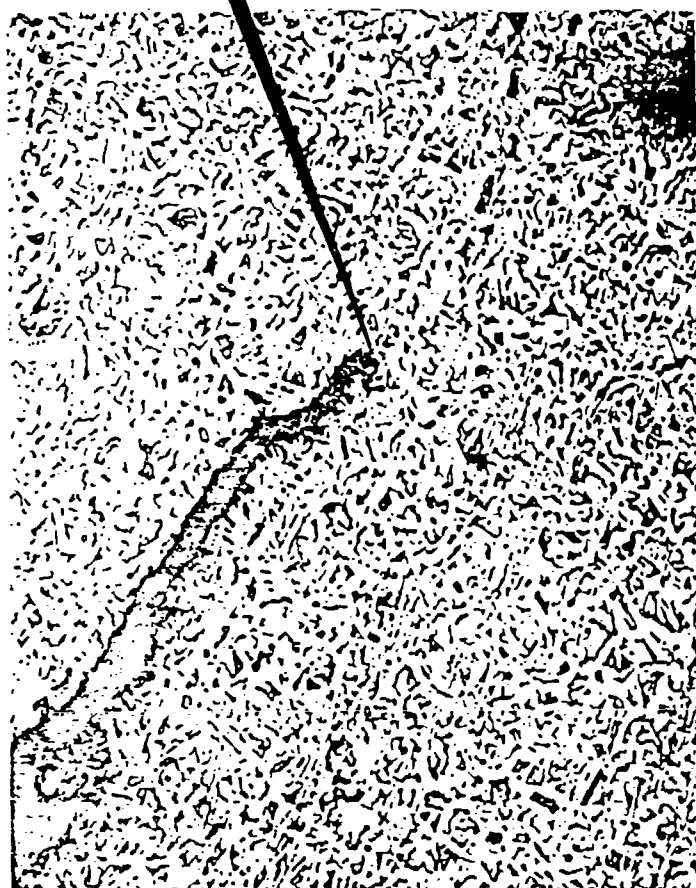
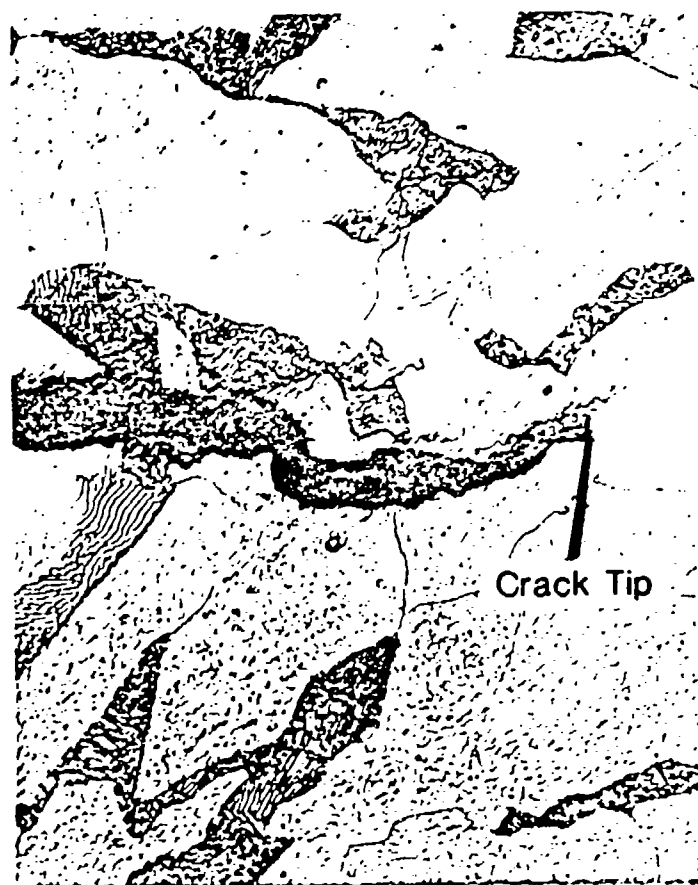
Figure 3-27 Microstructure in the vicinity of blunt crack tips of Figure 3-26

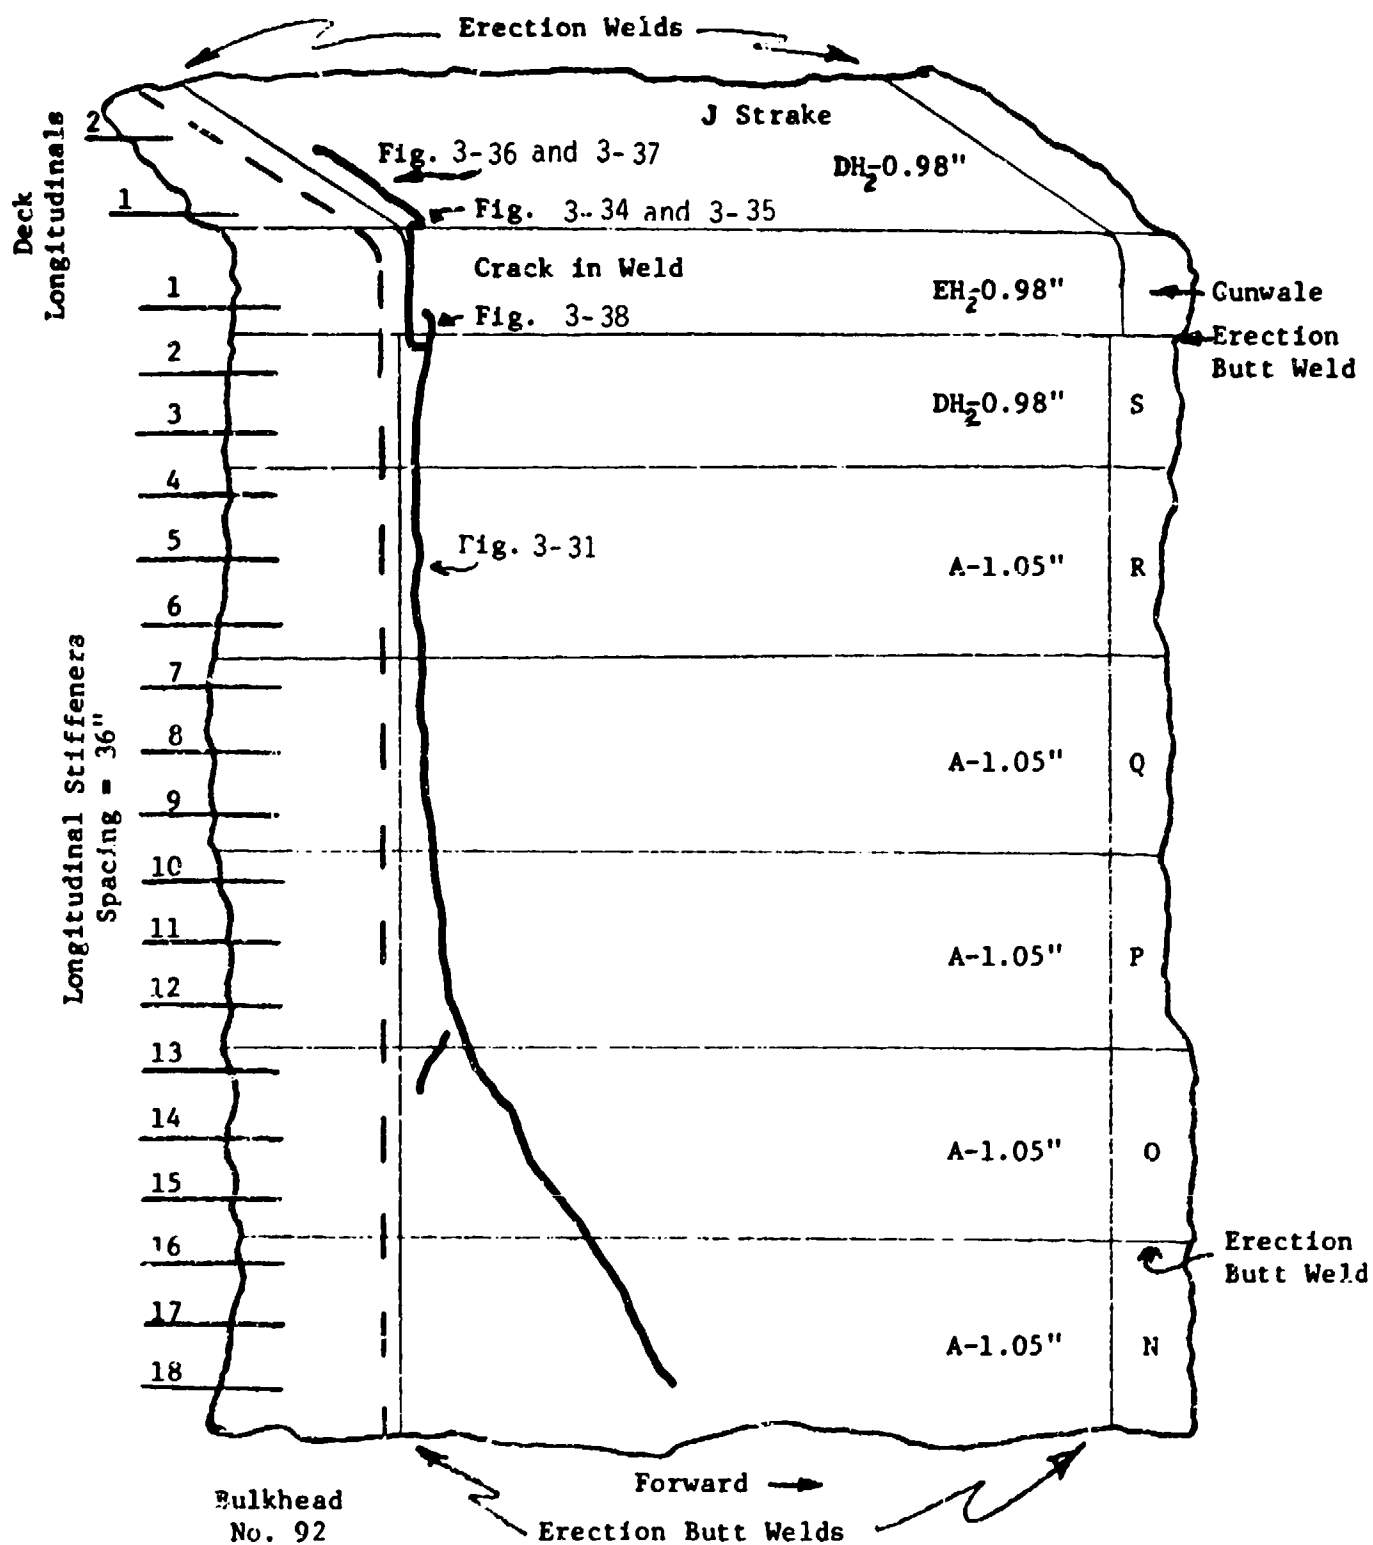
Figure 3-29 General View of Shell Fracture No. 3 Wing Tank Starboard

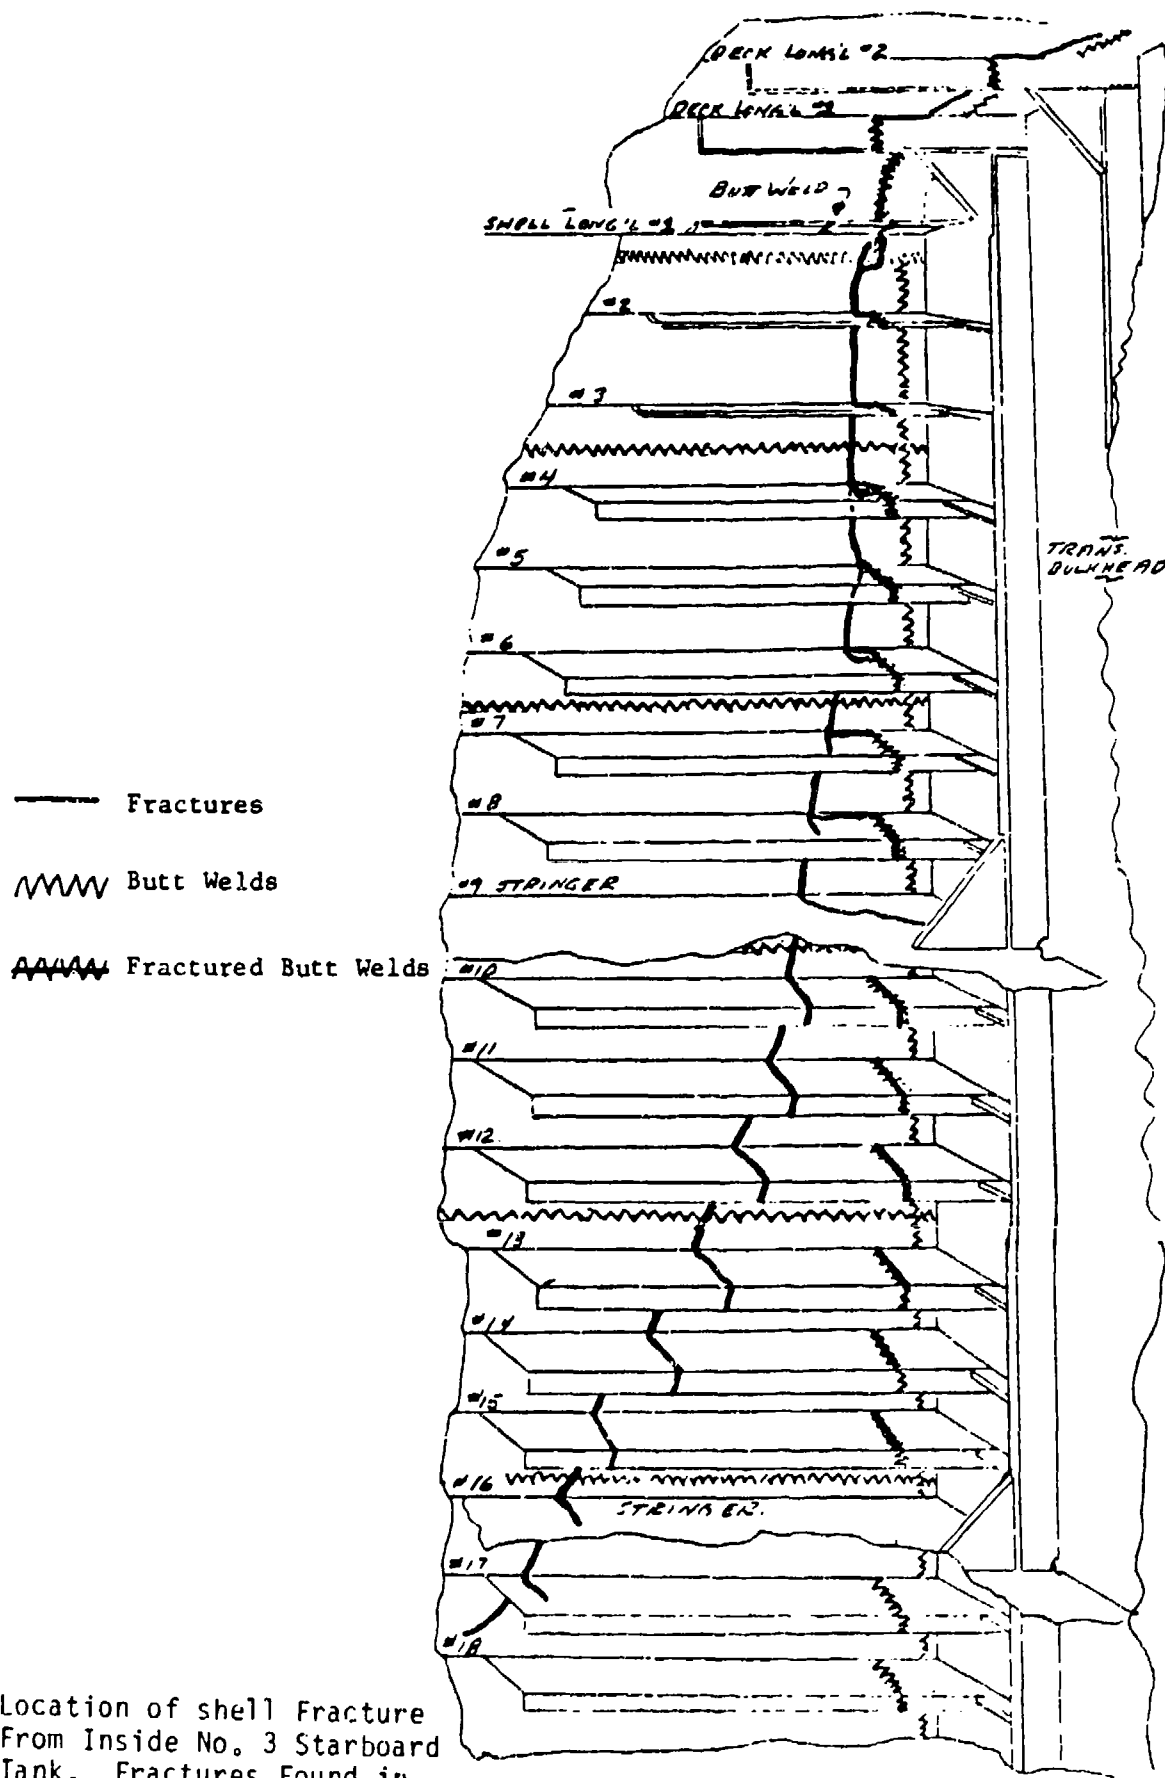
The main fracture, as shown in Figure 3-30, extends from the gunwale down to the "N" strake. Figure 3-38 shows the end of the fracture in the gunwale plate. The dimple at the end indicates that the energy at the crack tip was being absorbed by plastic deformation of the steel. Figure 3-39 is a photo-

Figure 3-30 Location of shell Fracture From Inside No. 3 Starboard Tank. Fractures Found in the Longitudinals also Shown

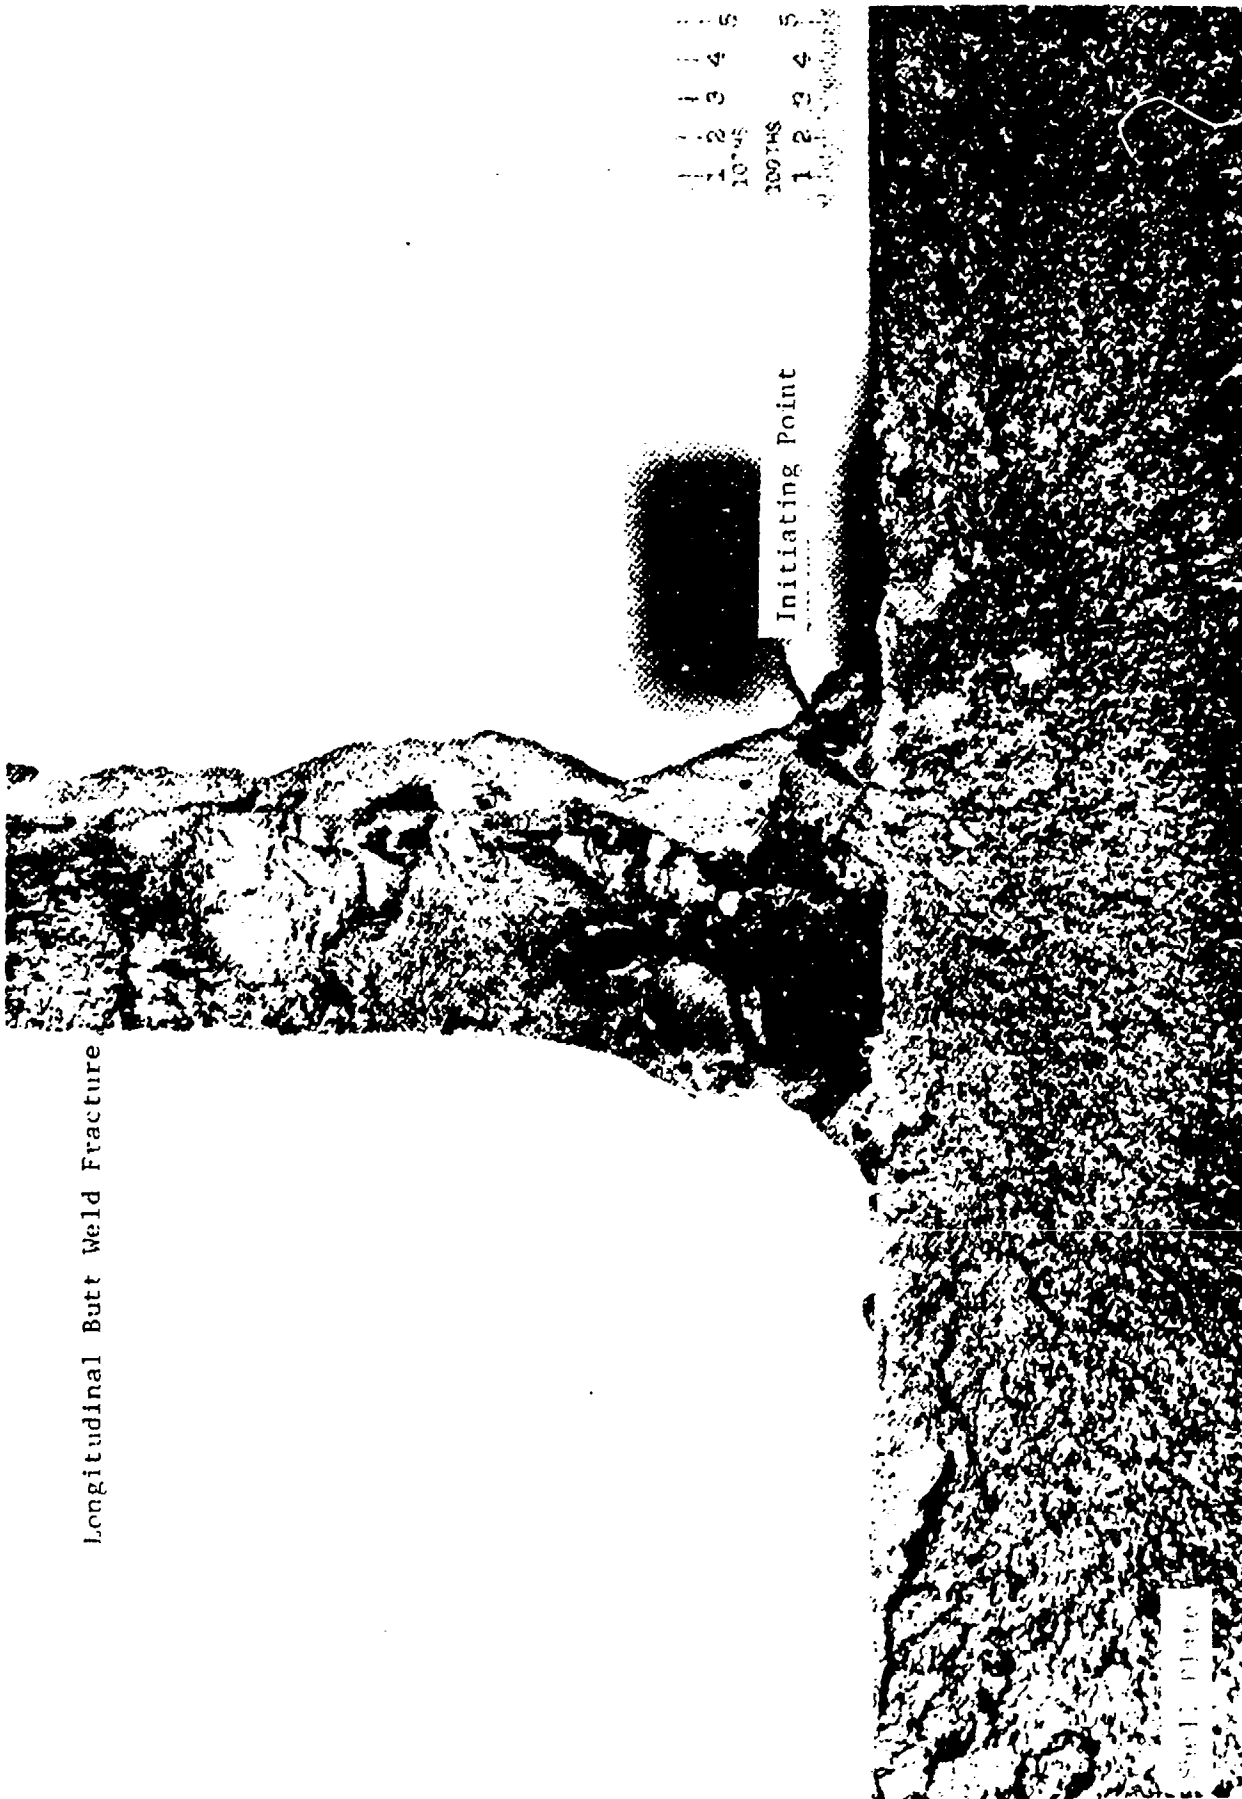
Figure 3-32 - Initiating point of brittle fracture in fillet weld joining No. 5 longitudinal to the shell plate.
Specimen No. 3908; Magn. 2x.
